Racine Water Treatment Plant Case Study

**960 Man/Hrs Saved Annually; ROI Gained in 3 Years;
“Won’t Have to Replace for 20 Years”**

Project: Racine Water Treatment Plant

Project Type: Rehabilitated equipment for municipal surface water treatment plant with a rated capacity of 60 mgd serving 110,000 customers.

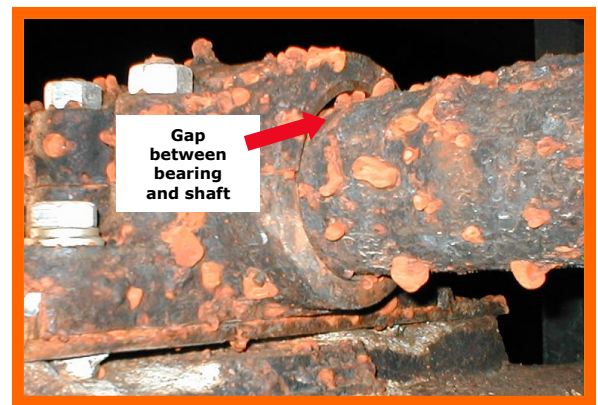
Clearly, the old bearings had irregular wear and had developed large gaps (see below right), causing shaft instability and eventual breakage. Replacing the bearings was very expensive and would not permanently solve the problem, but postponing replacement resulted in additional costs. Broken shafts slowed water movement and caused several feet of sediment to accumulate on the basin floors, which necessitated removal and increased maintenance costs. The impaired shafts also compromised creating the energy needed for optimal mixing and floc formation, and made achieving water treatment goals challenging.

BEFORE: Shaft and bearing at Racine, WI, facility prior to replacement with AMWELL Greaseless Flocculator Bearing System.

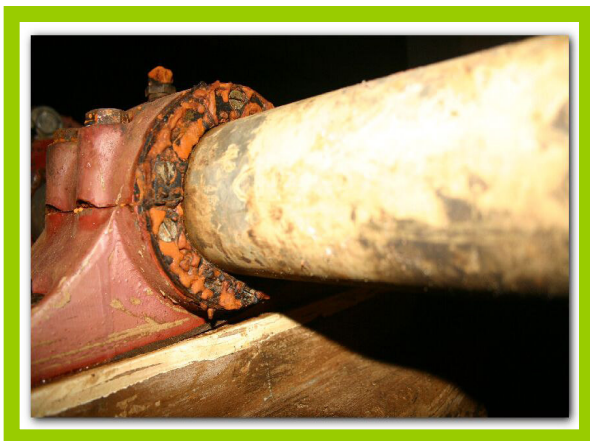
AFTER: Picture of AMWELL Greaseless Flocculator Bearing System at Racine, WI facility **after 3 years of use**

From the start, **AMWELL’s** full service approach saved Rick outside contractor fees and resulted in a collaboration addressing the plant’s needs for the least amount of cost. **AMWELL** designed the flocculation system to reuse the plant’s existing dry well drive system, while upgrading the shafts to lighter weight material, which finally solved bearing wear, shaft breakage, and related maintenance issues.

The Racine facility’s halls are now quiet. Rick commented that if the **AMWELL Greaseless Flocculator Bearing System** continued to perform as it has since 2005, “**We likely won’t have to replace this equipment for another 20 years,**” adding that the new equipment has virtually **eliminated any shaft or bearing breakdown**. The equipment is now reliable and capable of functioning under high stress and increased plant loads. Rick and his staff have not seen any shaft or bearing wear to date, and have been very satisfied with the experience of working with **AMWELL**.
