New DuraMax Cast Stainless Steel Chain
Saves 264 Man Hours Annually; Paid for Itself in 3 Years
“Takes care of itself. I can’t say enough good about it.”

Joliet Westside Wastewater Treatment Plant

Retrofit – Replaced cast iron rake chain with DuraMax cast stainless steel chain for automated chain and rake bar screen on a 50 foot deep by 4 foot wide bar screen for wastewater treatment plant with a rated peak capacity of 28 MGD serving approximately 40,000 municipal and industrial customers.

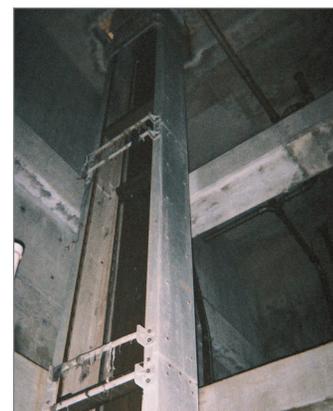
ABOVE: One of Joliet’s 50-foot tall vertical bar screens

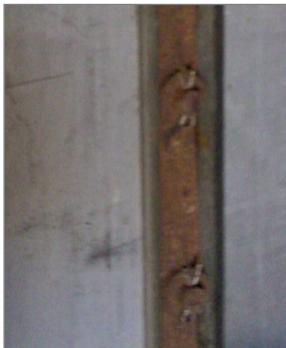
ABOVE: Cast iron chain installed in 2006 is already corroded and needs to be replaced (photographed in 2010).

- Cast iron scraper chain corroded and weakened; had to be replaced every 3 years making it expensive to own and operate
- Cast iron chain has no guarantee, so always a cost to replace when it broke

- Weakened chain stretched; required weekly adjustment which increased maintenance cost
- Some chain links would need to be replaced, resulting in maintenance cost and equipment downtime

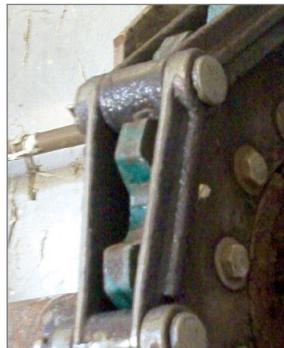
ABOVE: DuraMax Cast Stainless Steel chain installed in 2004 looks new; negligible maintenance since 2004 (photographed in 2010).

- Chain has worked fine with no need for replacement
- Paid for itself in 3 years, saves Joliet money in economically tough times
- Design life of 20 years means the chain will pay for itself almost seven times over
- Standard 10-year guarantee gives peace of mind

- Reduced cost by eliminating:
- Need for weekly chain tension adjustments (adjusted now just 1x per year)
 - Need to replace chain
 - Need to fix chain

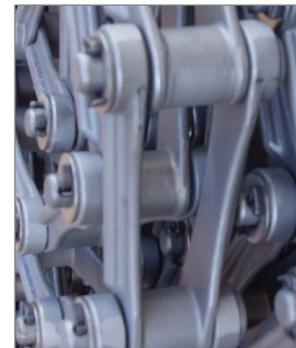
ABOVE: New DuraMax Cast Stainless Steel chain. Comparing new chain above to that installed in 2004, there is hardly a difference.
