New Cast Stainless Steel Chain Saves 144 Man Hours per Year Saves \$86,000 Over 20-Year Life in Labor Costs Alone ROI in 3 Years

Joliet Westside Wastewater Treatment Plant

Retrofit – Replaced plastic grit collector chain with DuraMax cast stainless steel chain for wastewater treatment plant with a rated peak capacity of 28 mgd serving 40,000 customers.

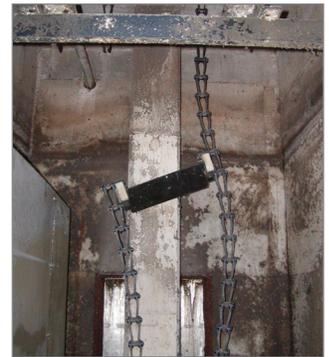
ABOVE: Broken plastic chain on grit collector

They say a picture is worth a thousand words. Such is the case with the picture (right) of the broken plastic chain on a grit collector, which tells a lengthy and costly story of good intentions gone bad. Several years ago, in an effort to reduce expensive maintenance on old corroding cast iron chain, a Joliet, Illinois wastewater treatment plant chose plastic chain as an inexpensive, easy-to-work-with replacement. At the time, plastic was lighter for staff to handle, and less expensive than many other materials on the market. Initially, it was a much needed improvement over the cast iron. However, "there were loads of problems with the plastic chain almost as soon as we put it in," notes Mark Paskvan, Chief Operator at the Joliet Westside Wastewater Treatment Plant in Illinois.

While plastic is a satisfactory equipment material, the stresses of extreme conditions in the Illinois climate, and at the Joliet plant in particular, were more than it could handle. First, Joliet sees extremes in hot and cold temperatures which expand and contract plastic, weakening it. Second, the high amount of abrasive sediment in the grit collector environment was too abrasive for this type of injection-molded plastic, causing further weakness. Third, grit collectors have high workload requirements, often exceeding the rated working load of plastic chain, which was the case at Joliet. This combination of weather, abrasion, and workload attacked the plastic chain, causing breakage soon after installation. Trying to save their investment, Mark remembers, "We had to visually inspect the chain to try to catch weaknesses in the plastic before breakage," noting that the inspection activity added to maintenance costs. But breakages, such as the one pictured, were also costly, often consuming 48 man hours at a time to repair. Despite their best efforts to be proactive, it was common for the plastic grit collector chain to break every three to six months. What started out as being a welcomed improvement over cast iron chain ended up being substantially more expensive in labor, maintenance, and replacement.
