TREATMENT PLANT OPERATOR

Bar None

SCREENING EQUIPMENT WITH LINKS CAST FROM STAINLESS STEEL ALLOYS INCREASES EFFICIENCY AT A MICHIGAN TREATMENT PLANT

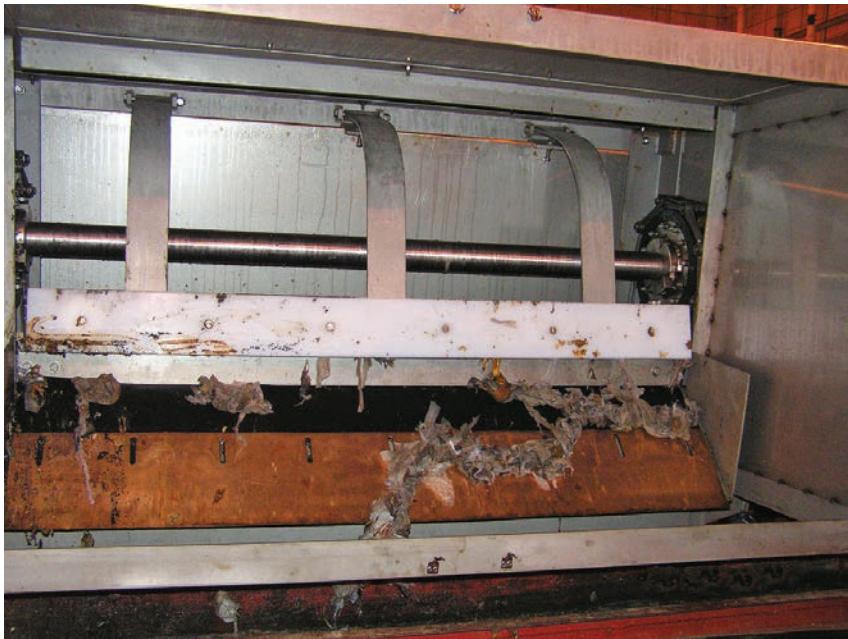
The screening system efficiently removes rags and other solid objects.

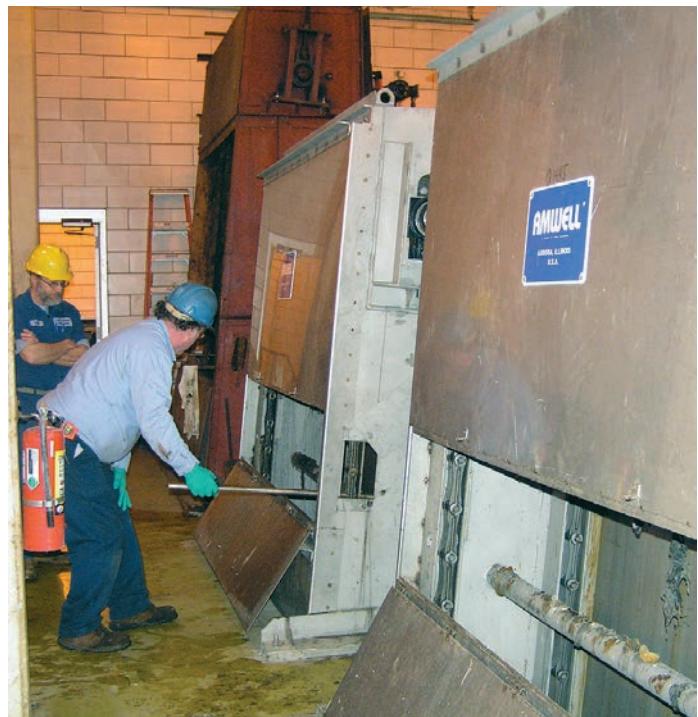
ABOVE: Operator/maintainer II Phillip Minich shows operator/maintainer apprentice Ed Marnon how to access the chain links on the screening system. RIGHT: The chain inspection port is behind a cover that is easily removed for service.

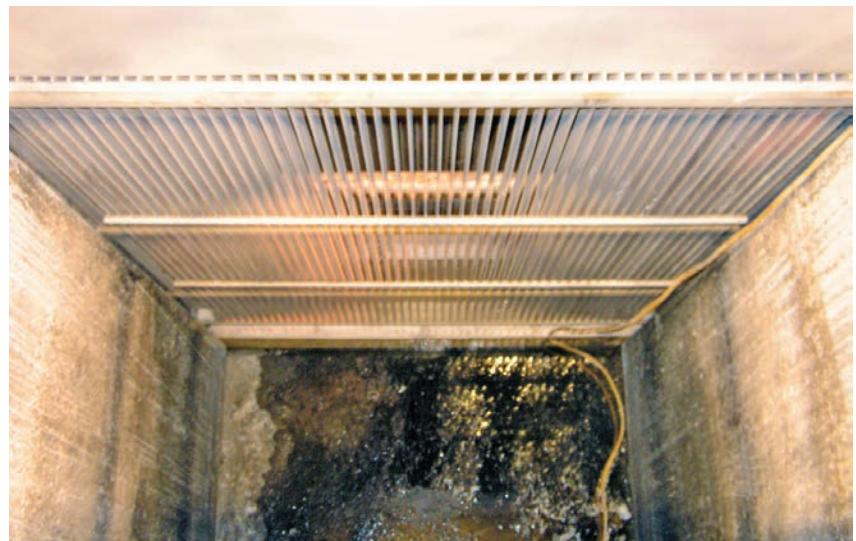
The screens have jam-resistant chain guides and bar racks with 1-inch openings.

The screens, built of 1/4-inch stainless steel frames, have jam-resistant chain guides and bar racks with 1-inch openings. Curved sidebars on the links reduce wear on the headshaft sprockets and increase load-carrying capacity. Tee-shaped full-length lateral ribs reinforce the chain sidebars. Rotating chain pins (inserted by hand from either side of the link) and pin bosses evenly distribute the load and wear throughout the joint contact surfaces.
